**TAUNTON RIVER BASIN  
TAUNTON, MASSACHUSETTS**

**PROSPECT HILL RESERVOIR  
MA 00811**

# **PHASE I INSPECTION REPORT NATIONAL DAM INSPECTION PROGRAM**

**APRIL 1979**

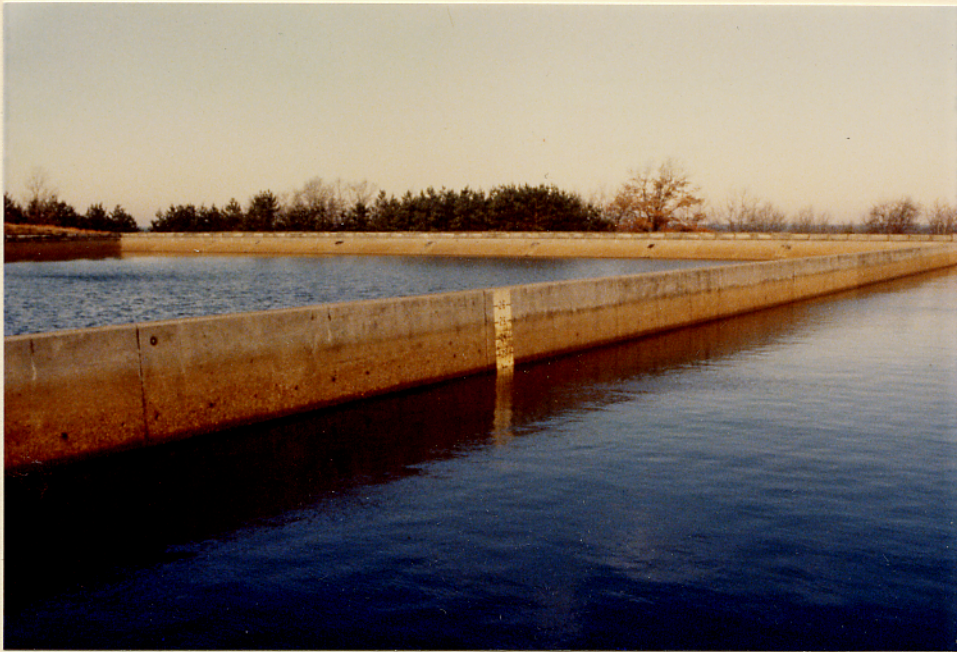
**NO. 1 VIEW OF CONCRETE WALLS OF RESERVOIR**

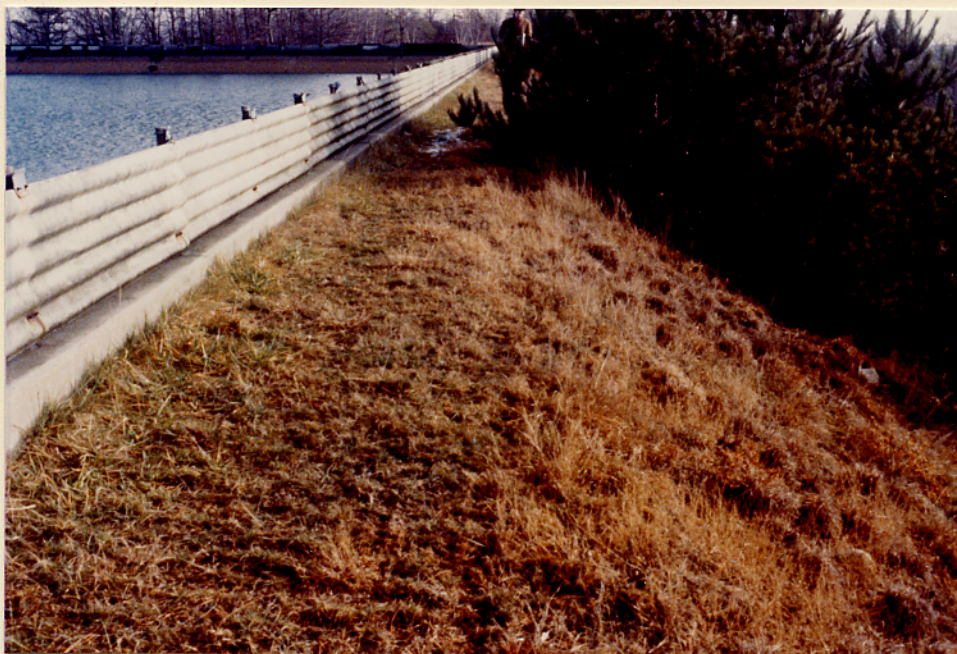
The embankment is constructed of random earth fill and serves to support the sides of the reservoir. The outside slope is at 2:1 and is covered with grass; some areas were planted with pine trees for erosion control. Minor surface erosion was noted in places. No seepage or settlement of the embankment was visible.

**NO. 2 VIEW OF CREST AND SLOPE OF EMBANKMENT**

- (1) selectively remove trees from the slopes of the earth embankment,
- (2) repair leakage from some joints on conduits in the gate house,
- (3) repair leakage from a gate valve on the outlet conduit,
- (4) monitor and measure the leakage from the underdrain system. Any changes should immediately be evaluated.
- (5) conduct periodic technical inspections of the reservoir and appurtenances every two years.

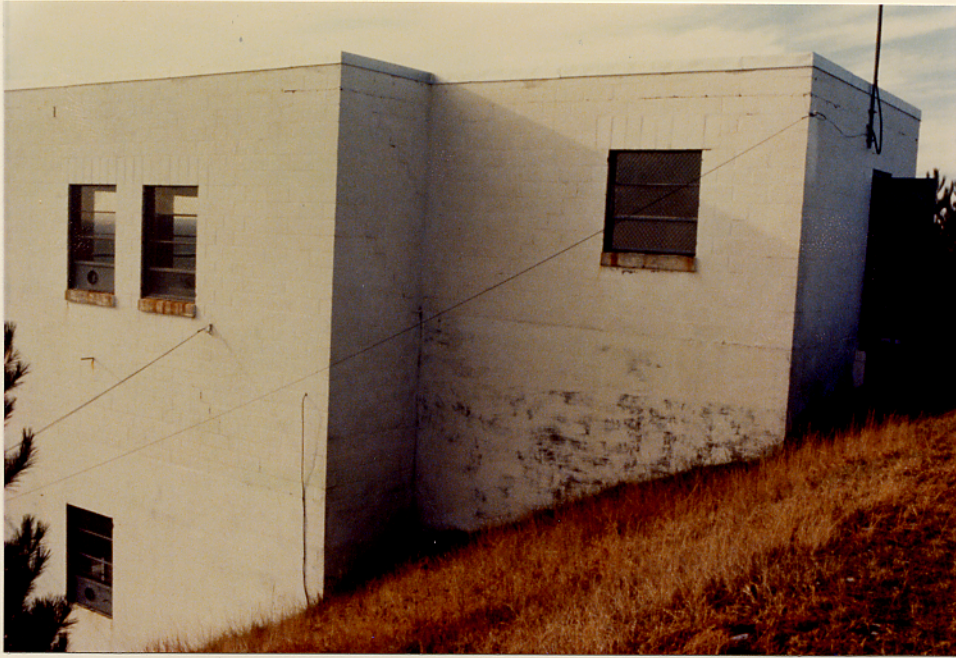
south side of the reservoir. The building is made of concrete and is in good condition. The conduits are made of cast-iron with bell and spigot joints. Minor staining and leakage was observed at some joints. Seepage and staining was also visible where conduits extend from the wall in the screen house to the gate house.

**NO. 3 VIEW OF GATE HOUSE ON SOUTH SIDE OF RESERVOIR**

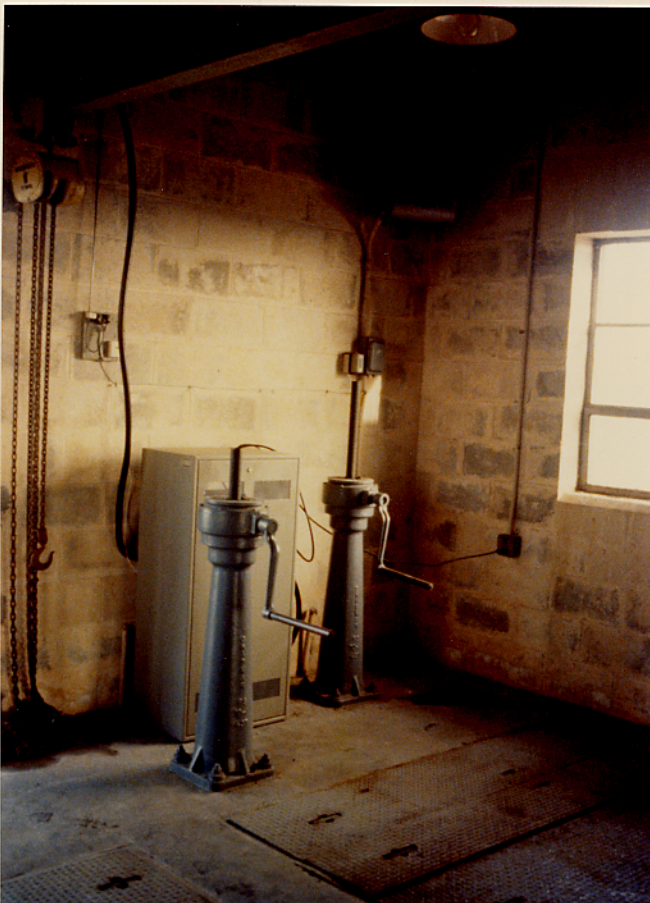
**NO. 4 VIEW OF OPERATING MECHANISMS FOR SLIDE GATES**

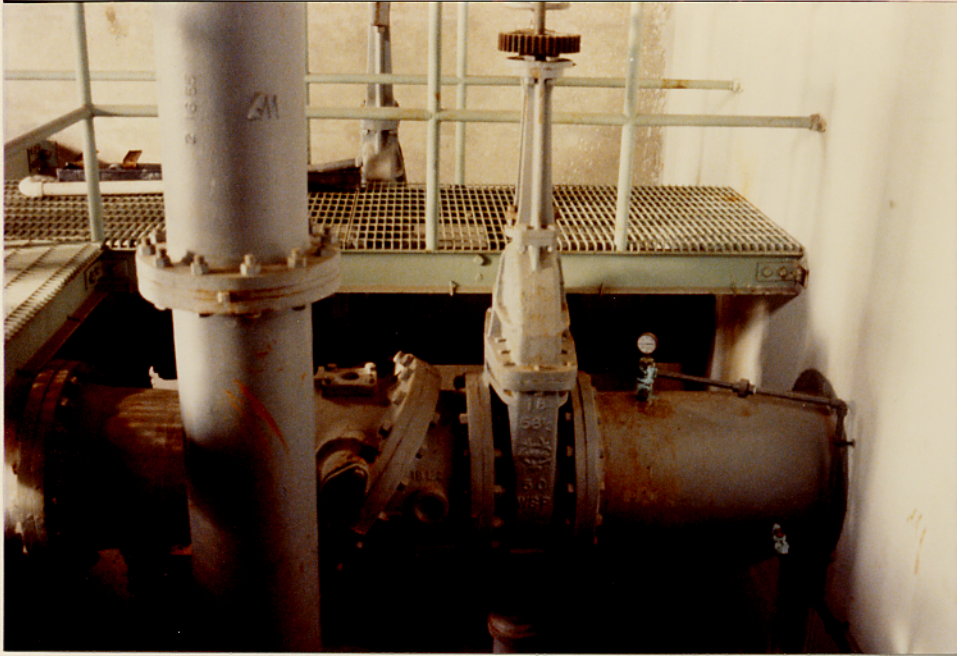
**NO. 5 VIEW OF OUTFLOW PIPE SHOWING  
GATE CONTROL AND CHECK VALVE**

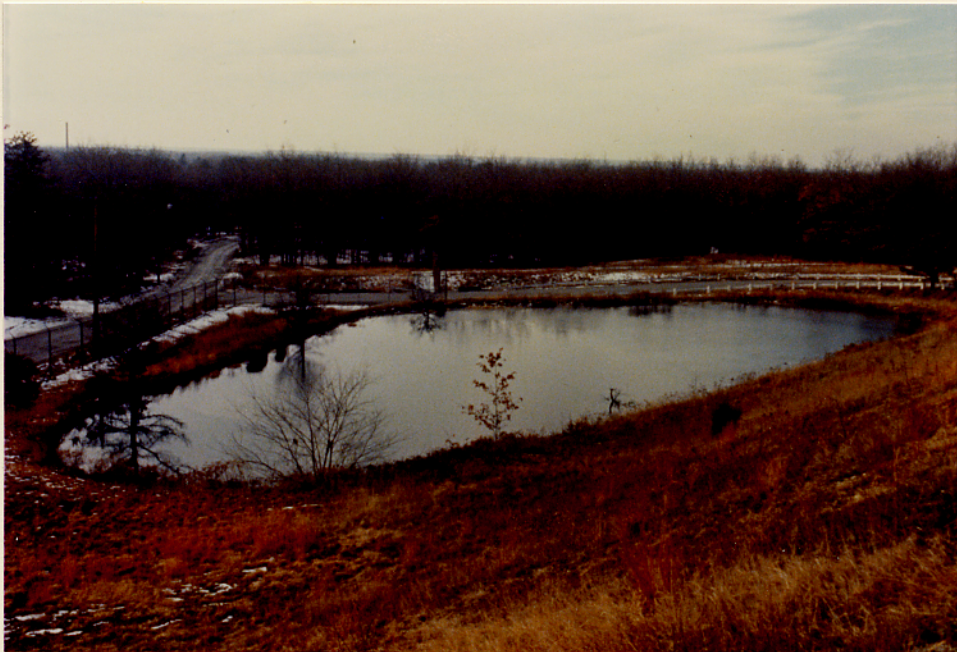
About 200 feet below the gate house is an overflow pond constructed with a bermed earth dike around about half of its perimeter. The pond receives flow from a 6-inch underdrain and a 12-inch outlet conduit. There is no outlet for the pond, and water was slightly overflowing the dike at the time of inspection. This is mainly due to discharge from the underdrain. However, the outlet conduit is also reportedly discharging due to leakage from a gate valve. The crest and slope of the dike are covered with grass. There are also two small trees growing on the crest. The slope and crest are locally eroded where water has overtopped the dike, and the water is flowing downhill in a ditch along the toe of the slope. There is no riprap protection for the slope of the dike or the sides of the ditch along Prospect Hill Street.

**NO. 6 VIEW OF OVERFLOW BASIN**
